FEASIBILITY STUDY AND REPORT

WINTER GAMES FACILITIES

FERRYSIDE RECREATION GROUND

GEO Turf Consulting Limited

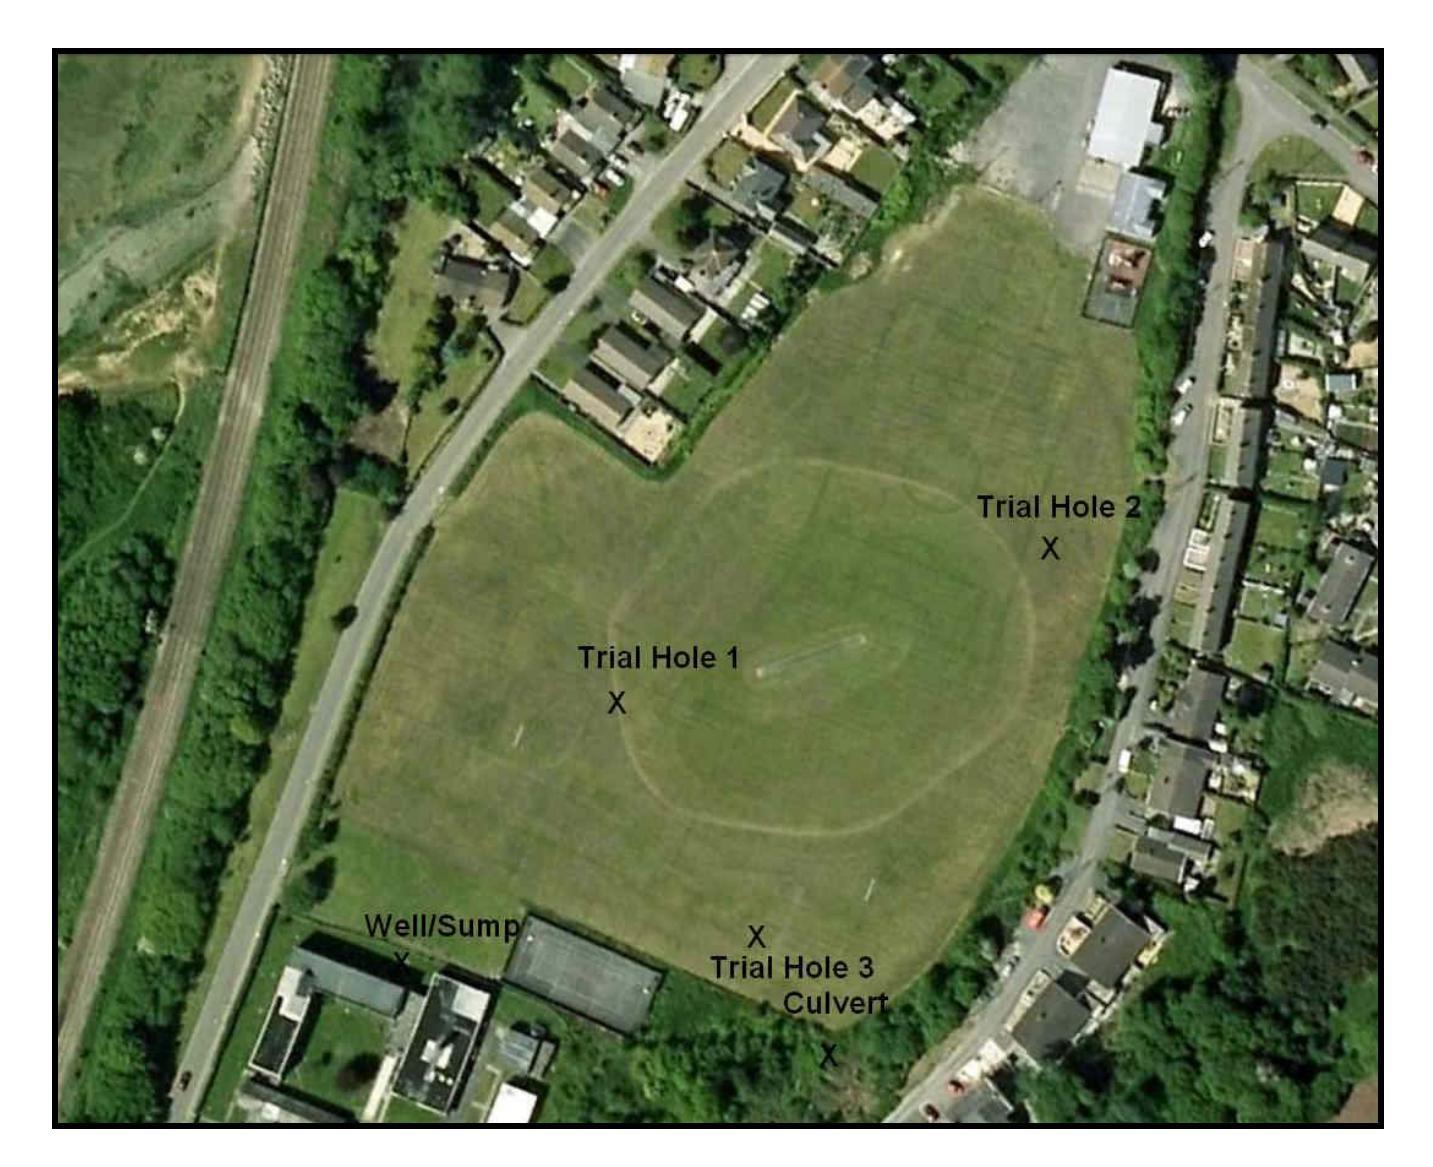
Photograph 1 - Aerial photograph showing approximate location of site boundary and trial holes

A visual examination of three trial holes (see Appendix 1 photograph 1 for the approximate locations) within the upper soil profile, revealed approximately 200mm depth of friable red/brown loamy sand topsoil over loose clay subsoil or stony made ground.

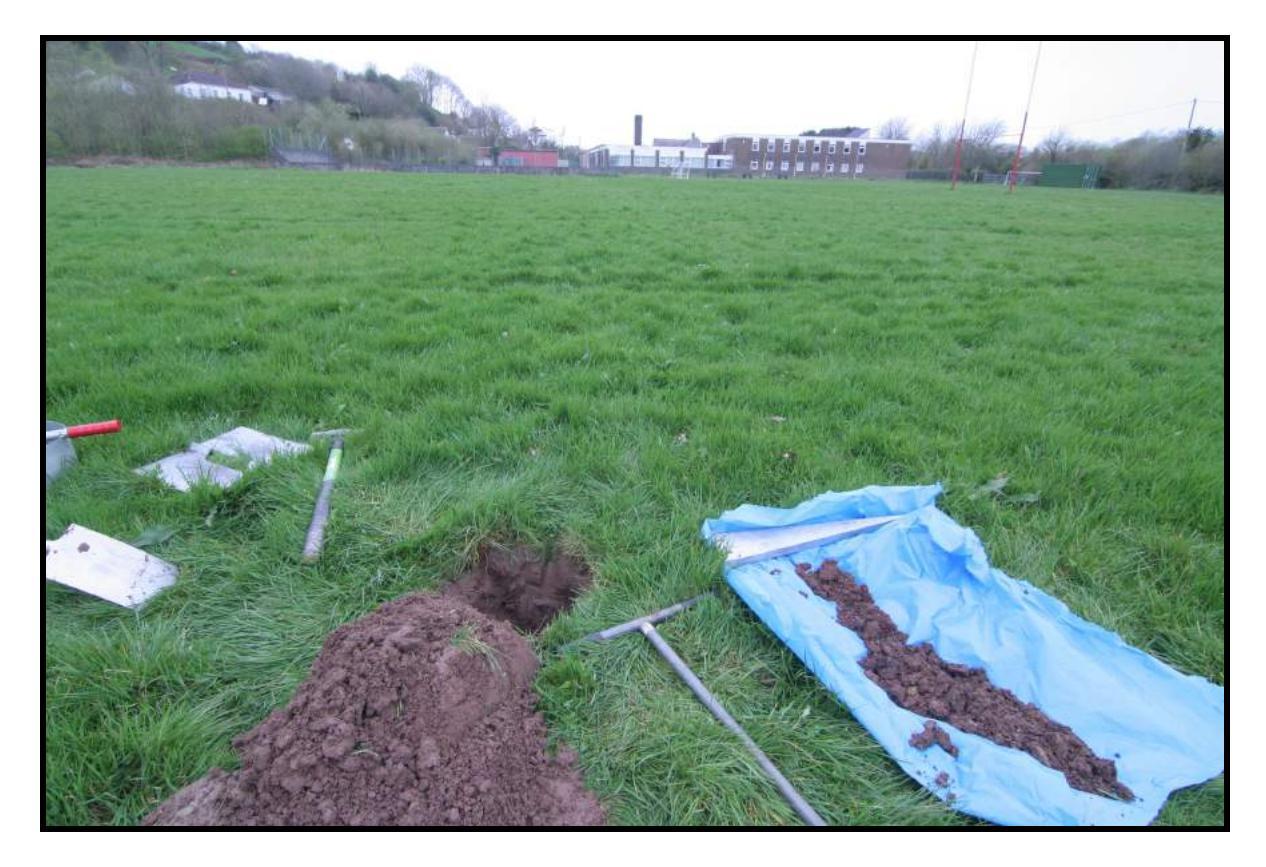
Depth (mm)	Description
0 – 200	Moist red/brown loamy sand topsoil – friable and well structured. Large cobble noted.
200 – 500	Red clay subsoil - friable and loose with large amount of stone.
500 - 800	Moist and friable clay-based made ground with coal fragments.
Notes	No Groundwater noted.

Photograph 2 – TH01 – Loamy sand topsoil with increasing stone content with depth over sandy/clay subsoil.

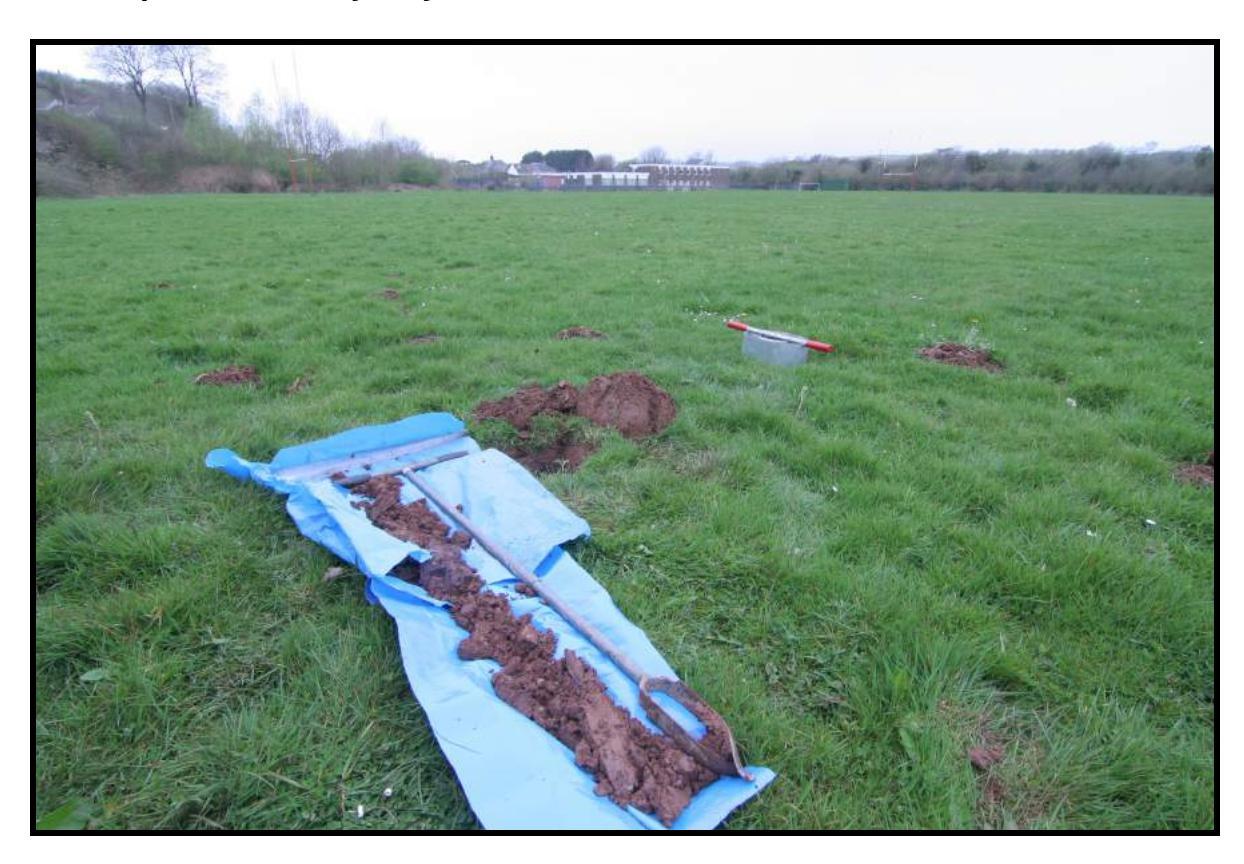
Depth (mm)	Description
0 - 200	Very moist red/brown loamy sand topsoil – friable and well structured with low stone content.
200 - 800	Friable sandy clay subsoil.
800 – 1000	Wet sandy subsoil
Notes	Possible groundwater below 800mm depth.

Photograph 3 – TH02 – Loamy sand topsoil with increasing clay content subsoil with depth.

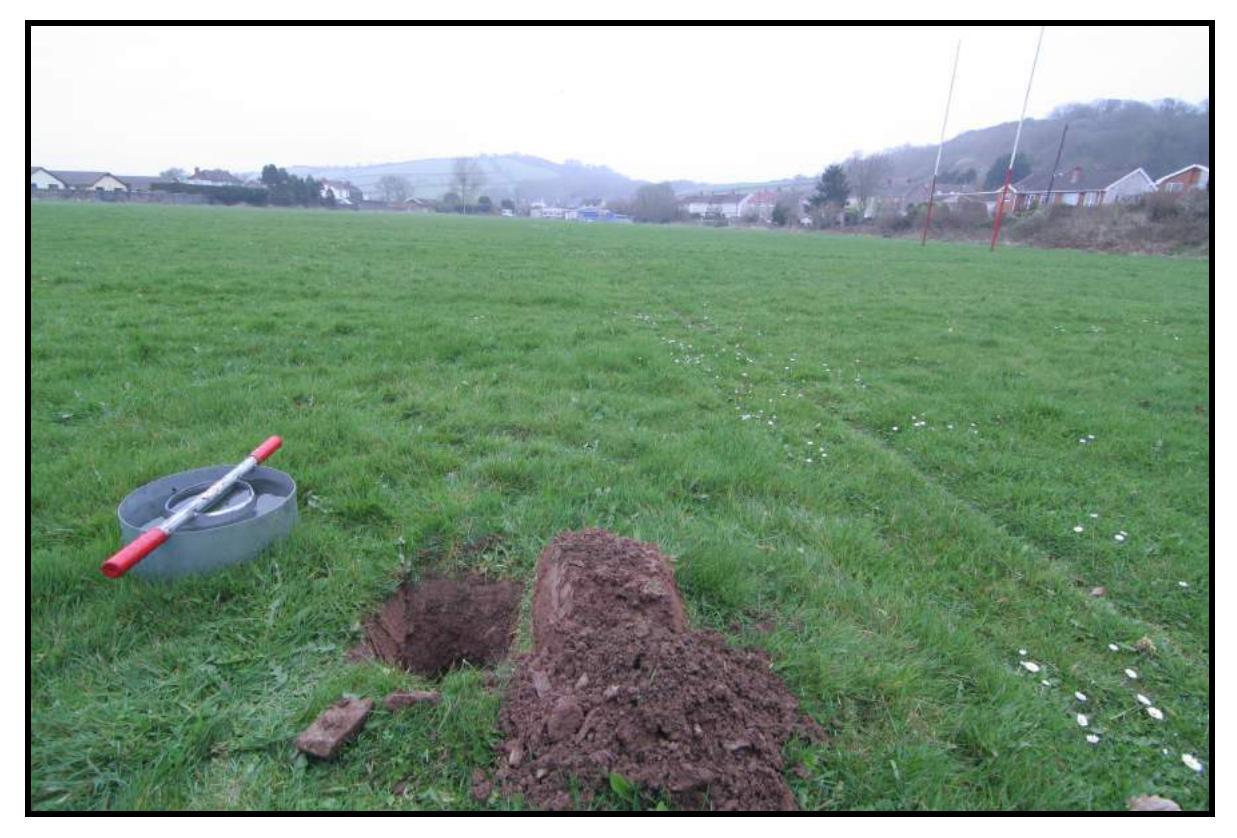
Depth (mm)	Description
0 – 200	Moist red/brown loamy sand topsoil - friable and well structured.
200 – 300	Made ground. Large yellow angular stone.
Notes	Depth of excavation limited due to presence of hard angular stone.

Photograph 4 – TH03 –Loamy sand topsoil over stony made-ground subsoil.

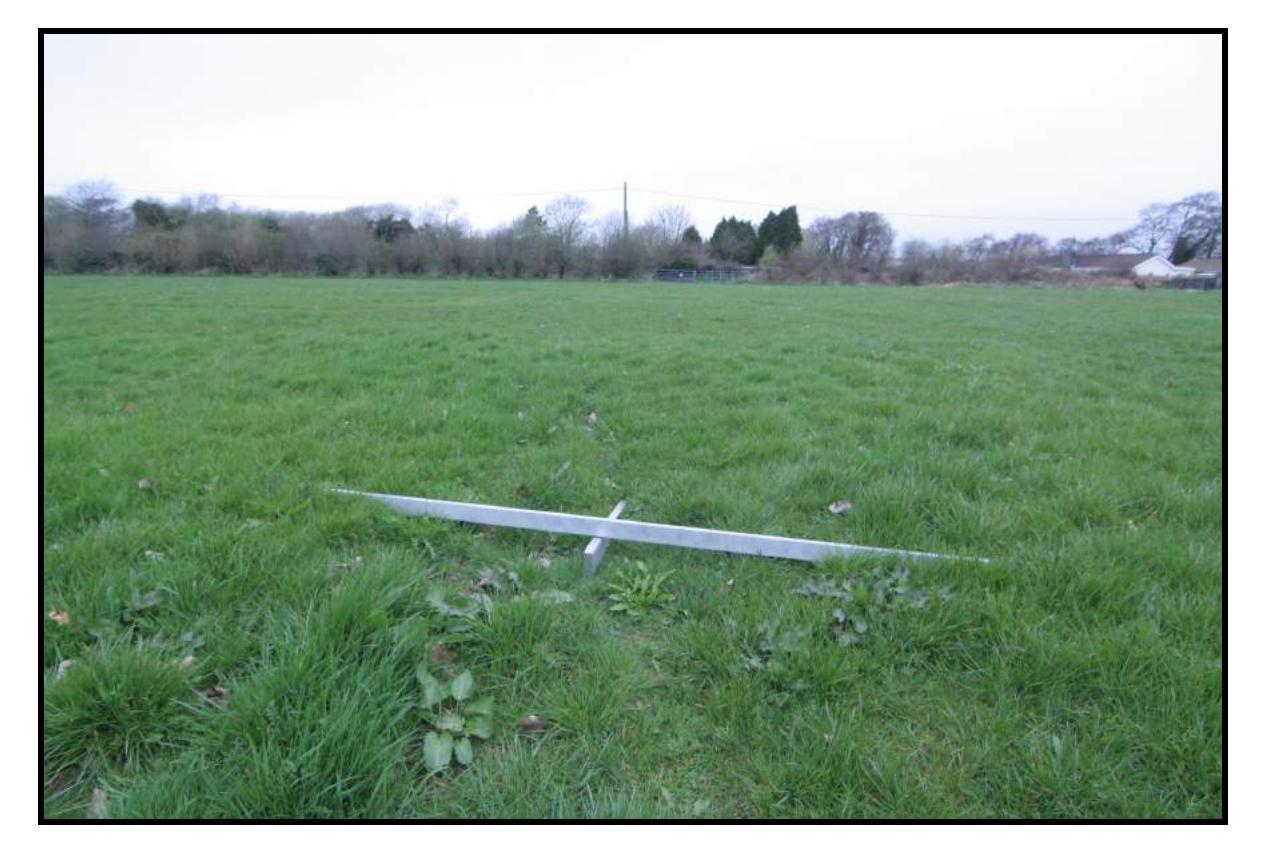
Localised surface evenness was generally poor and this will be exacerbating the poor drainage problems being experienced with surface water tending to shed and pond in dips. The surface would therefore benefit from laser grading to remove undulations and dips.

Photograph 5 – Poor surface evenness

Large areas have very poor localised levels. The levels in these areas could be cultivated, graded using topsoil removed from the surface of more level areas of the site and then reseeded. It should be noted that at least 150mm depth of topsoil should remain in place over the subsoil following grading work. The work could be carried out at the same time as installing the drainage system, but the treated area would not be available for any use for at least one year and only light use for the 2^{nd} year.

It should be noted that in some more uneven areas the above works may not be adequate or practical and these areas may only be levelled by stripping the topsoil to stockpile and grading the subsoil and then replacing the topsoil to a minimum 150mm depth. Ideally the area should be subjected to a detailed topographic survey so that the degree and extent of unevenness can be fully assessed.

Approximately half of the field has poor surface evenness, and in some areas localised levels are very uneven. Levels could be corrected by complete grading of the upper soil profile and moving topsoil into low areas. Some of the poorest areas may require the topsoil to be stripped and the subsoil graded followed by topsoil replacement.

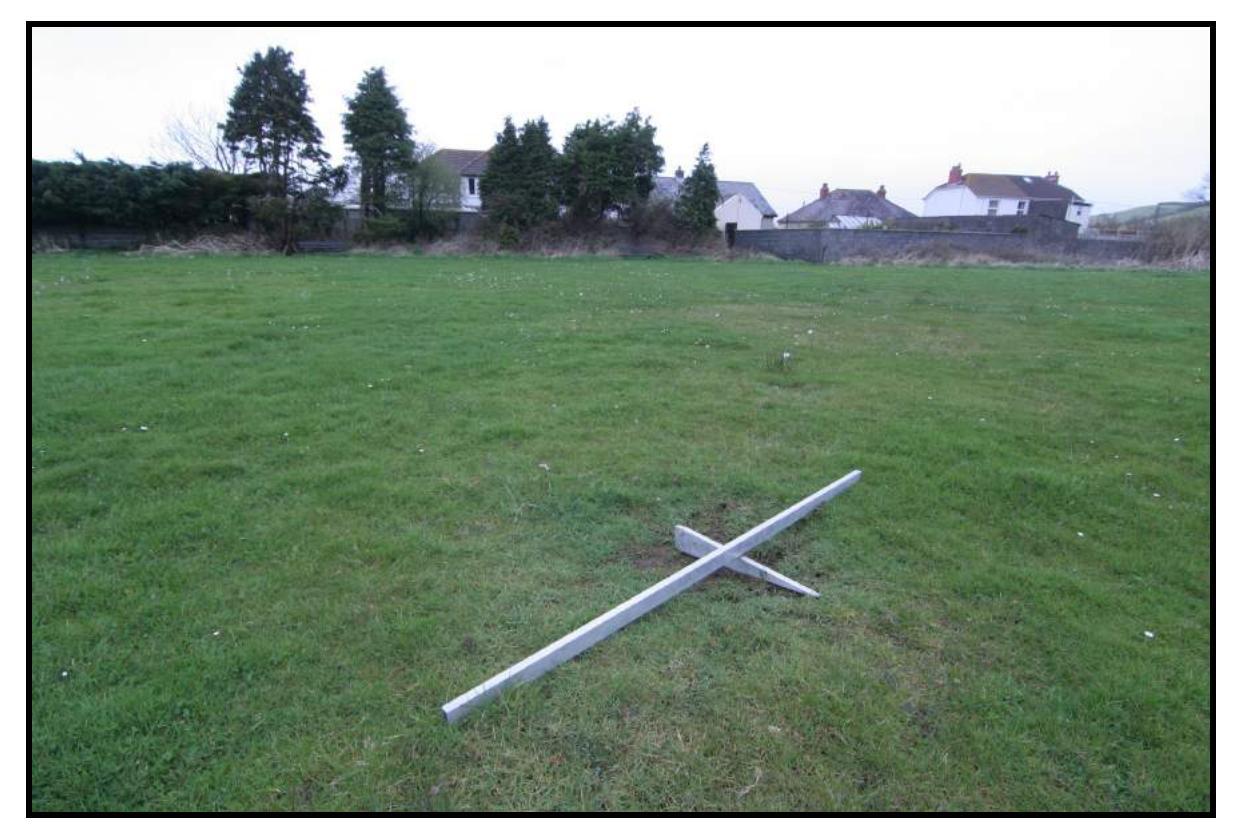
Photograph 6 – Poor surface evenness which is potentially hazardous

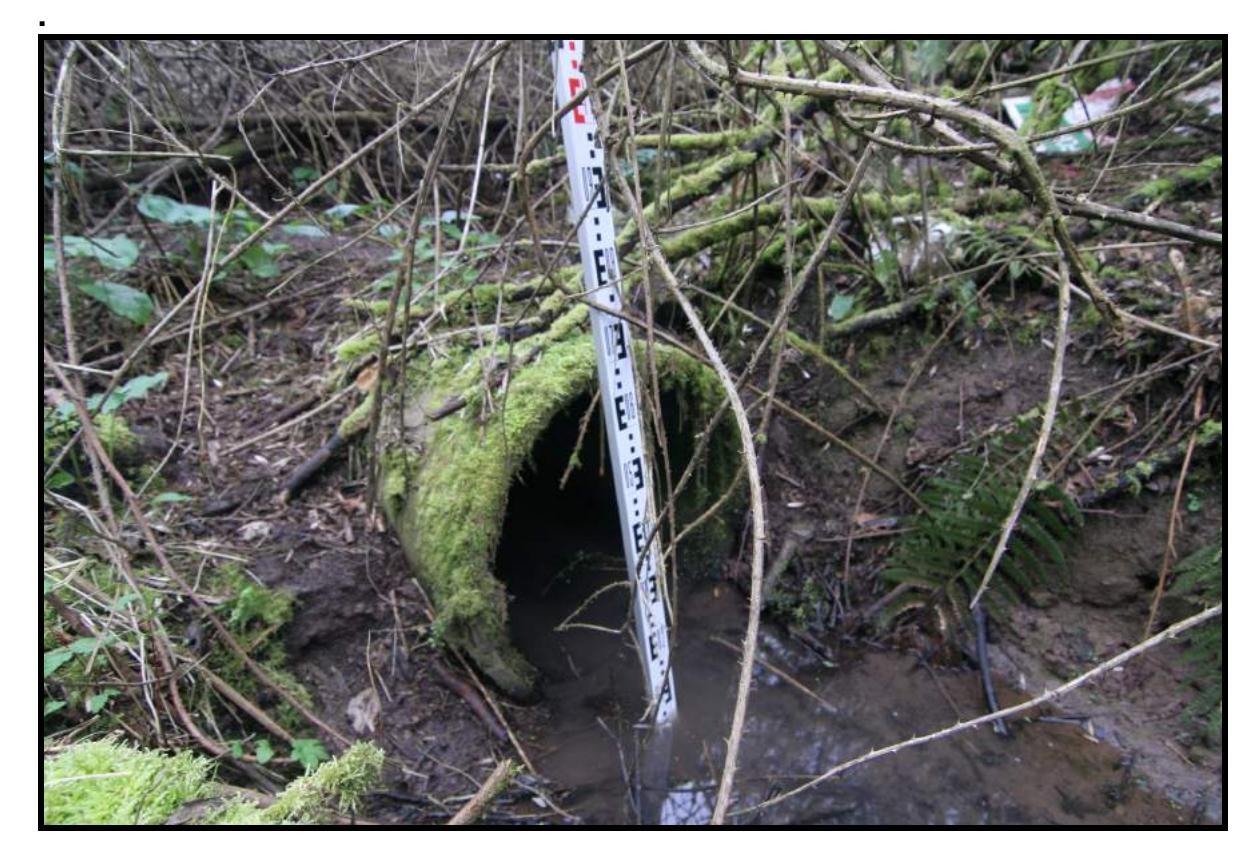
A 600mm dia concrete culvert appears to cross the site. The southern end of the culvert is shown in Appendix 1 photograph 7. From an extract of a map presented to Jonathan Smith while on site it appears that this culvert runs through the length of the site from south to north and is located approximately 20m in from the eastern site boundary. The soffit of the culvert at the southern end appears to be just below ground level. If the culvert remains at the same depth through the site, then it would be very difficult to connect a new pipe drainage system into this pipe. This is a problem because there is no fall on the site and any new pipe drains would therefore need to be installed with a minimum fall of 1:250. This would mean that the invert of the main outlet pipe would need to be between approximately 1.2m and 1.8m below ground level depending on the design of the drainage system. The invert of the 600mm pipe at the southern end of the site was approximately 700mm. this problem could however be over come if a float pump was installed to the main outlet chamber. This however would require a power supply and maintenance and is not ideal.

Photograph 7 – Inlet into 600 mm dia culvert

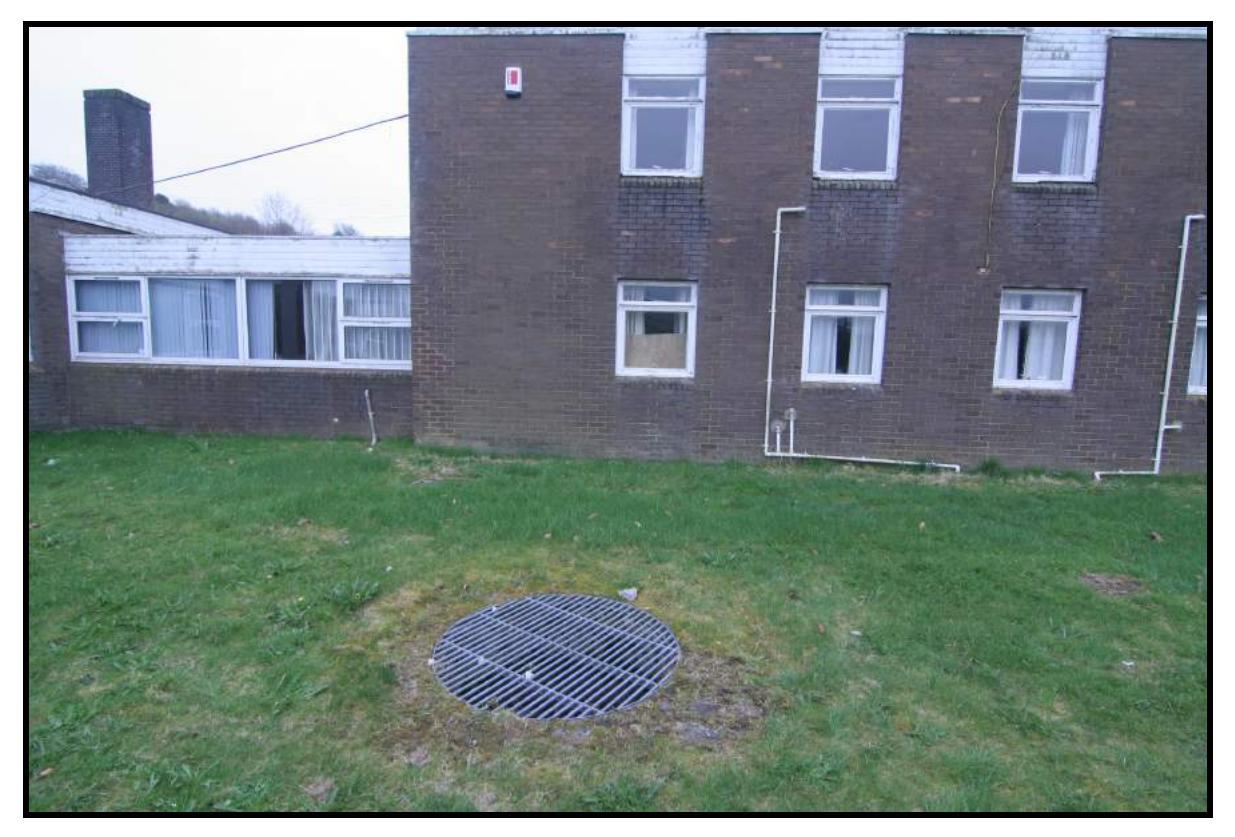
Photograph 8 – Well/sump adjacent to Learning Centre

The most promising option for a positive gravity drainage outlet point appears to be the well/sump located adjacent to the Learning Centre. This option should therefore be investigated further. It should be noted that placing drainage water into this feature may impact on the adjacent building and specialist advice should be taken from structural and hydrology Engineers if this option is to be pursued.

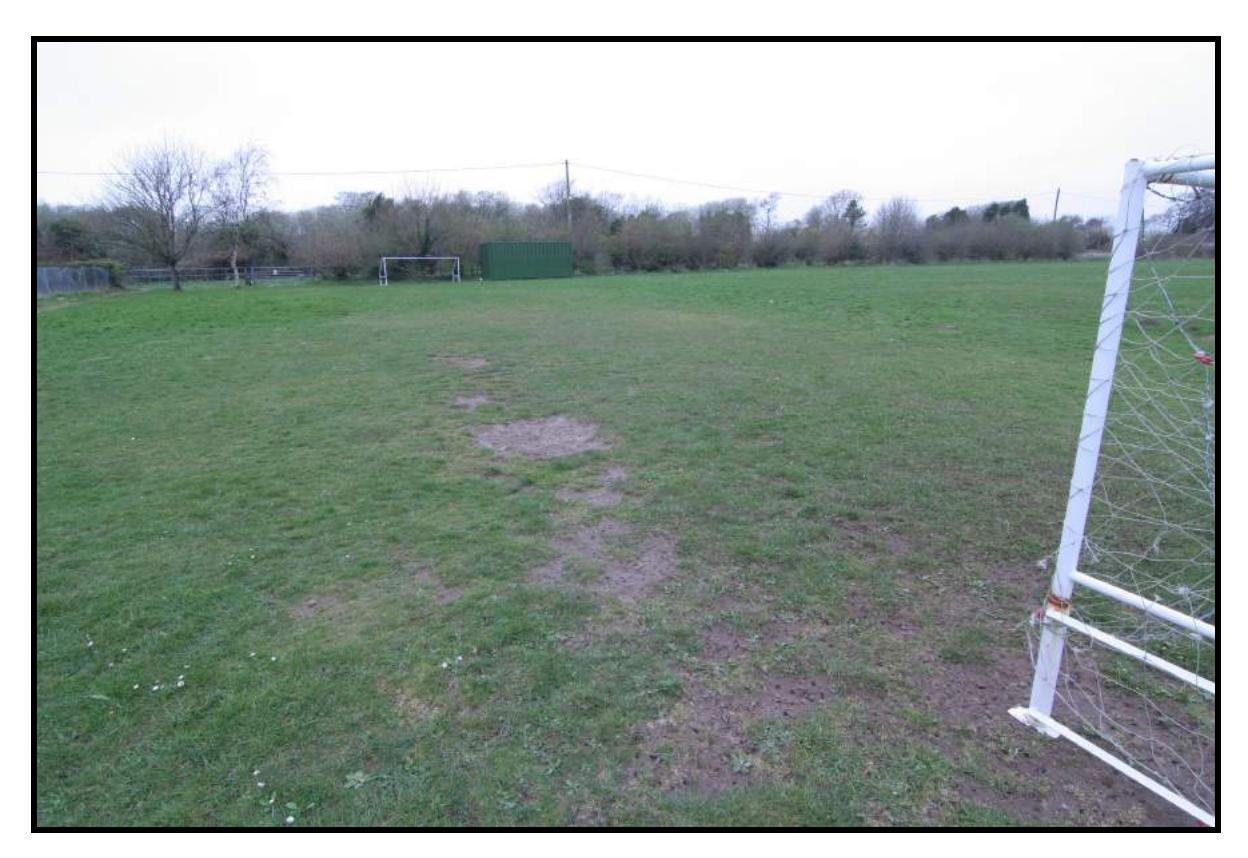
The existing grass sward comprises a variable density (60% - 90% cover) mixture of perennial ryegrass and annual meadow-grass. Weeds were noted, the most common weed species being clover, dandelion and daisy. The height of cut appeared to be between 80mm and 150mm and ideally this should be reduced to between 40mm and 50mm.

Photograph 9 – Very poor grass cover and levels on mini football pitch

The whole area should be sown with a high quality sports turf seed mixture containing a high proportion of wear-tolerant ryegrass comprising at least three different cultivars of perennial ryegrass, rated not less than 7.2 for Live Ground Cover in Table S1, Pages 6-7 of Turfgrass Seed 2011 (published by the STRI and BSPB Amenity Committee). An appropriate mixture would be:

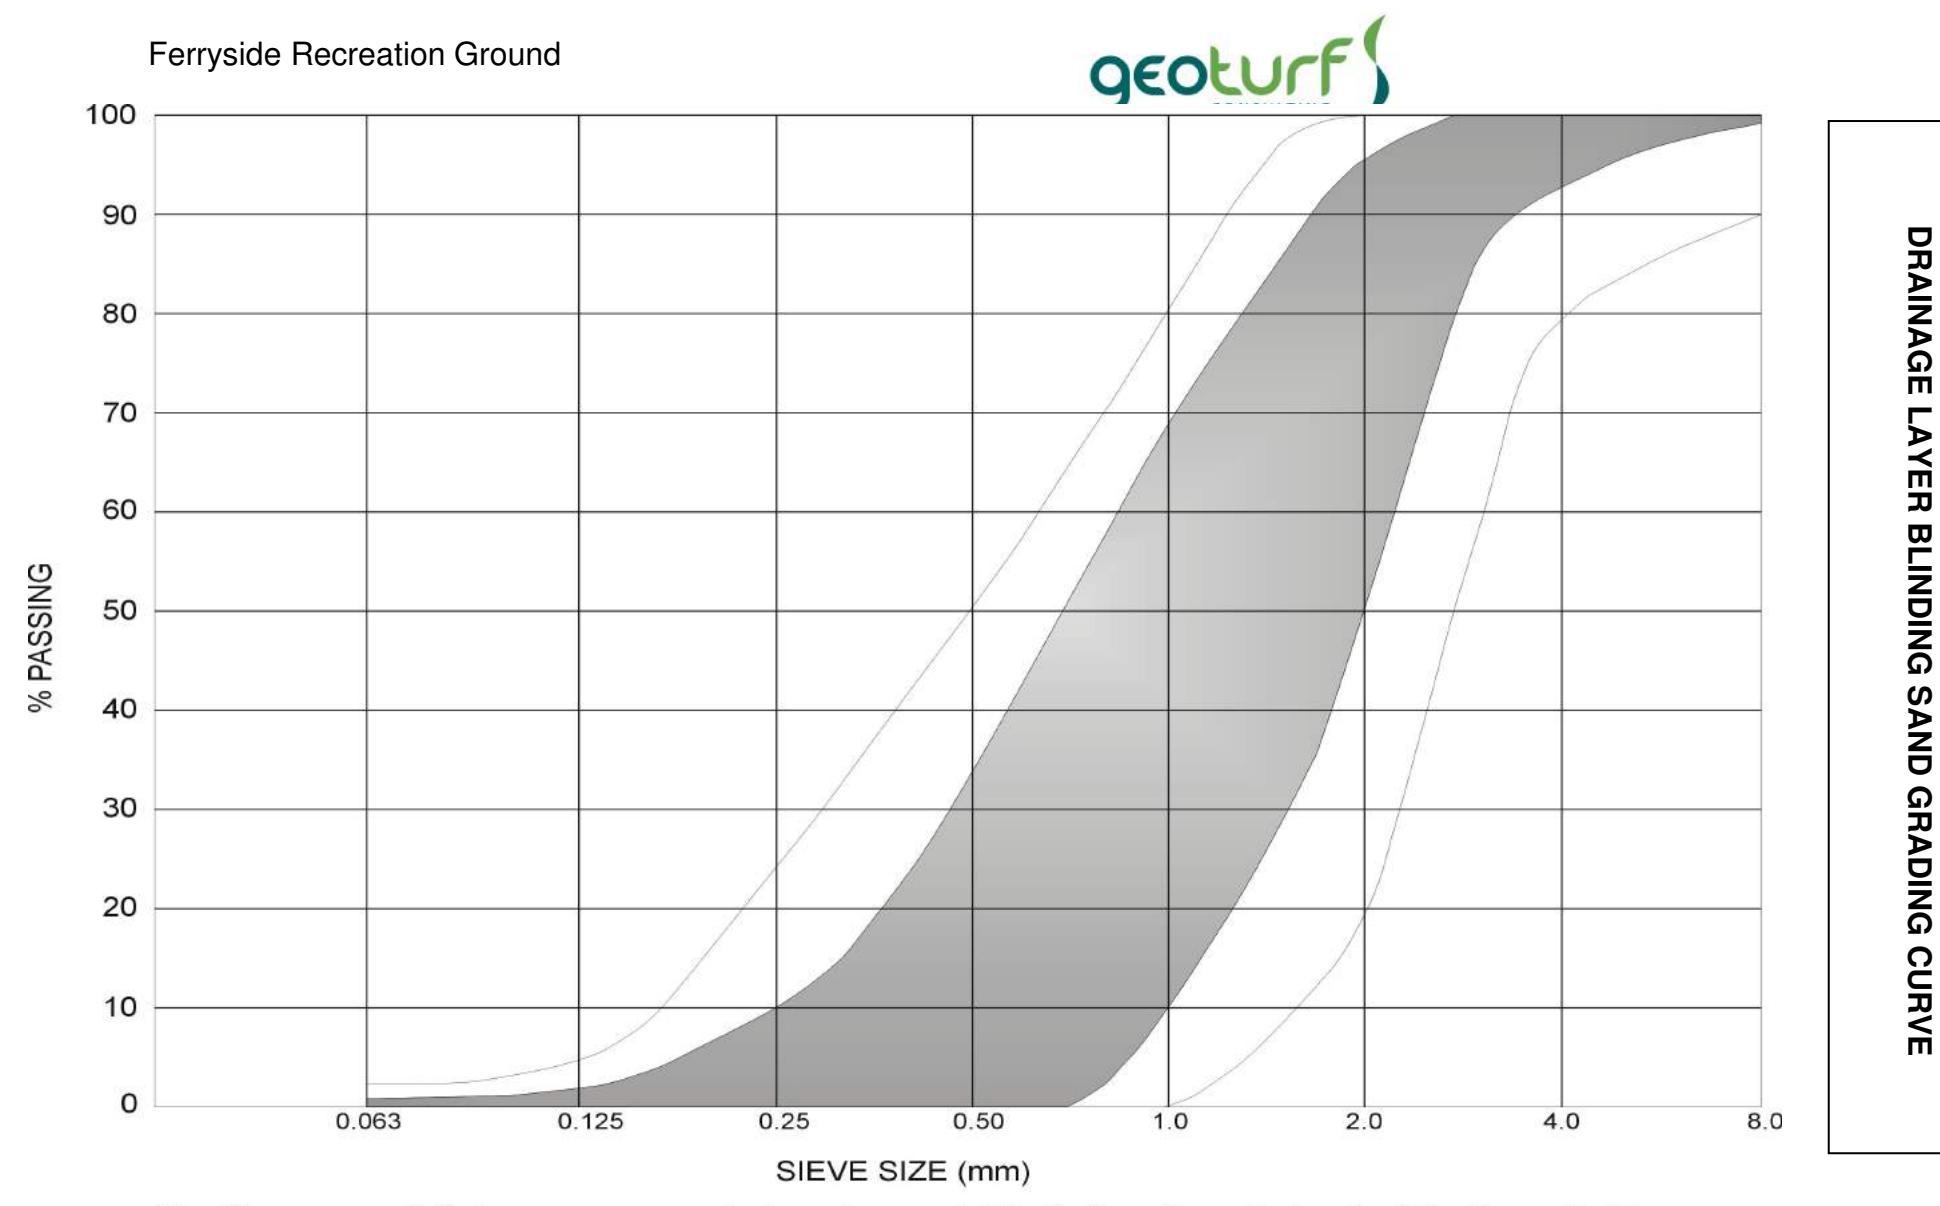
GRADING CURVE BLINDING SAND - PIPE DRAINS

Grading curve defining recommended and acceptable limits of sand size for blinding a 5-10mm drainage aggregate.

The trench should be backfilled to within 150mm of surface levels with (approved) 5 -10mm grade, clean, hard (non-calcareous), angular gravel or broken stone.

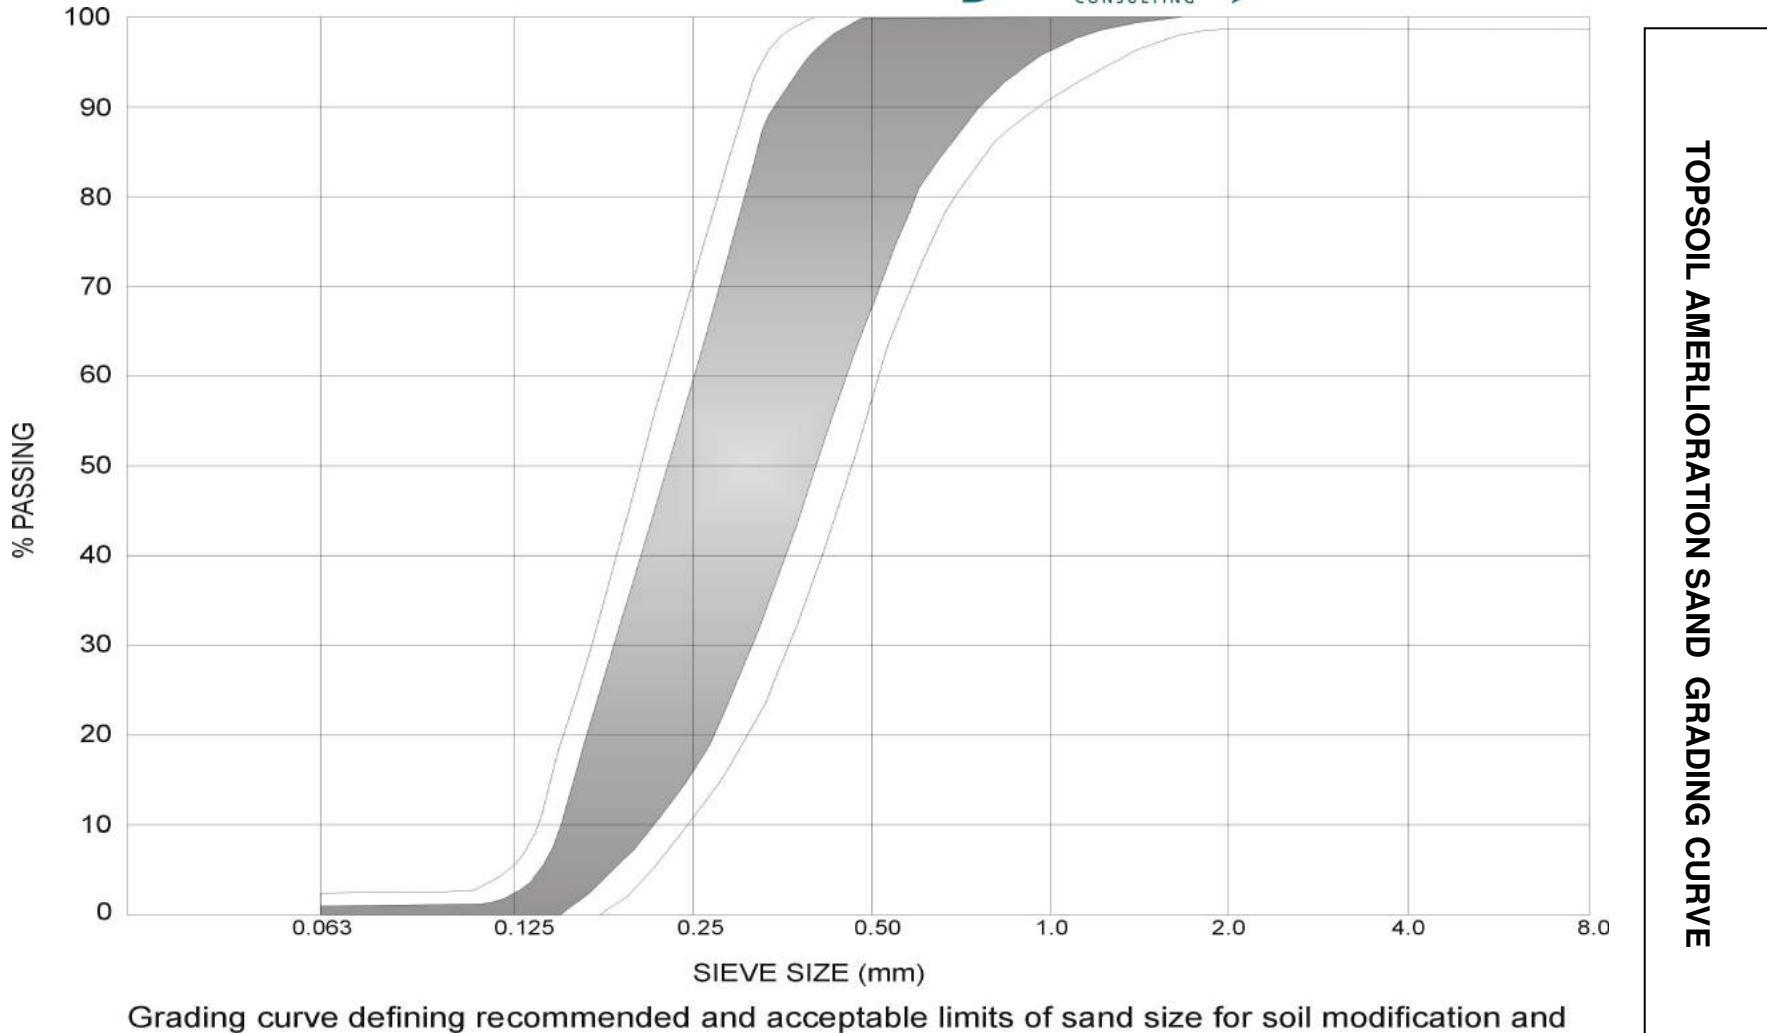
Ferryside Recreation Ground

top dressing of winter games pitches.

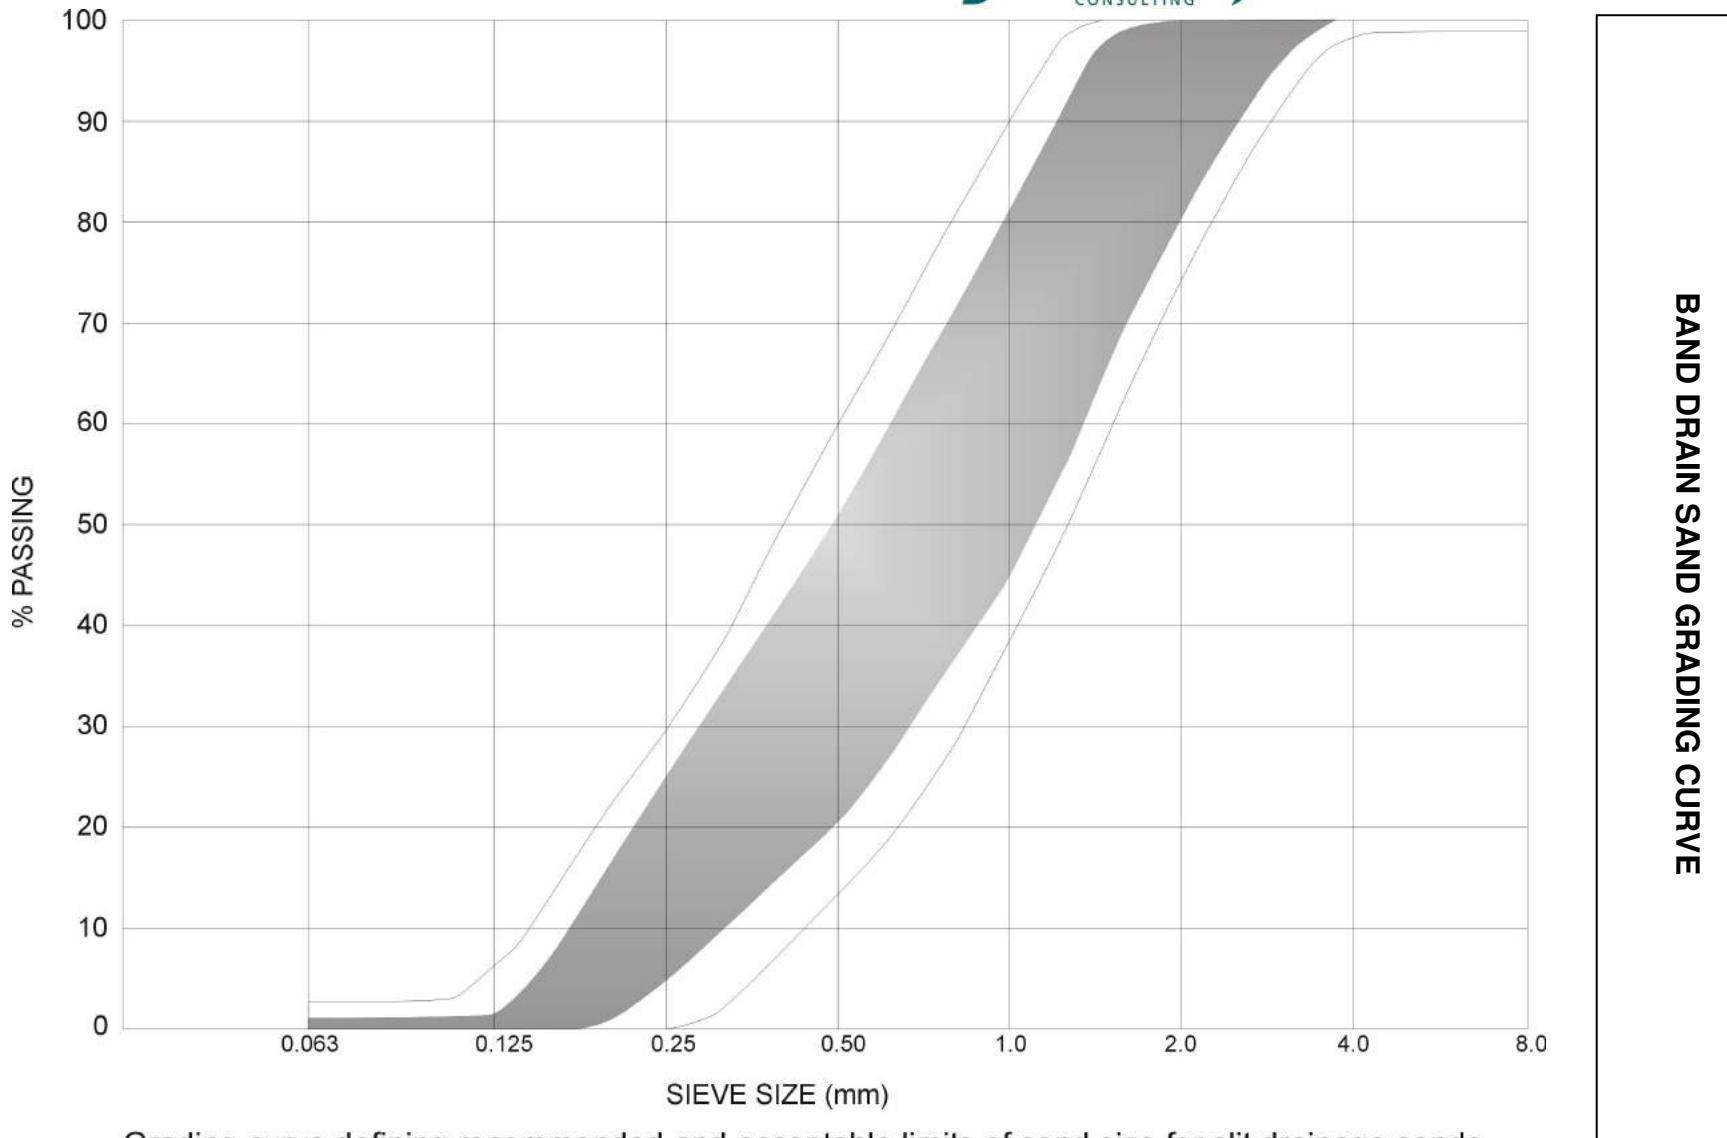
GRADING CURVE COARSE SAND – SAND BANDS Ferryside Recreation Ground

Grading curve defining recommended and acceptable limits of sand size for slit drainage sands for placement over a 5-8mm gravel in the base of the slit.
